Manhole Inspection Summary

Manhole # S37S__036MH

Inspection ☐ Is Incomplete Rating: **3) Fair**

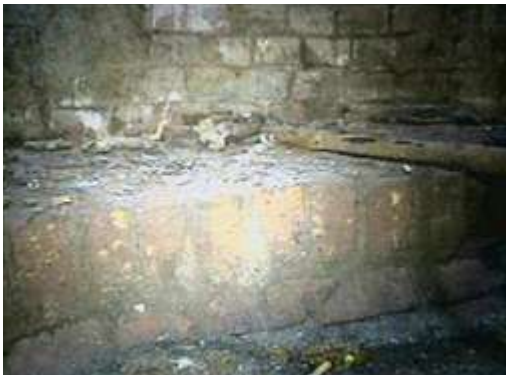
Defect 2

Condition: ☒ Sound ☐ Cracked ☐ Root Intrusion ☐ Deteriorated ☐ Leaks ☐ Debris

bench debris

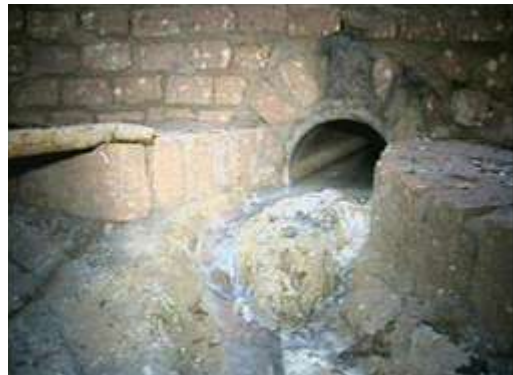
Defect 1

Condition: ☐ Sound ☐ Cracked ☐ Root Intrusion ☐ Deteriorated ☐ Leaks ☒ **Debris**

channel debris

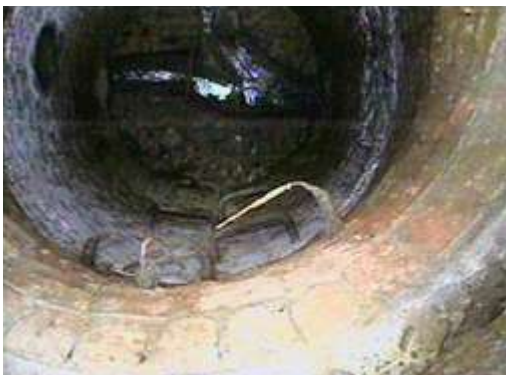
Count: **6** Missing: **2** ☒ **Corroded**

corroded steps

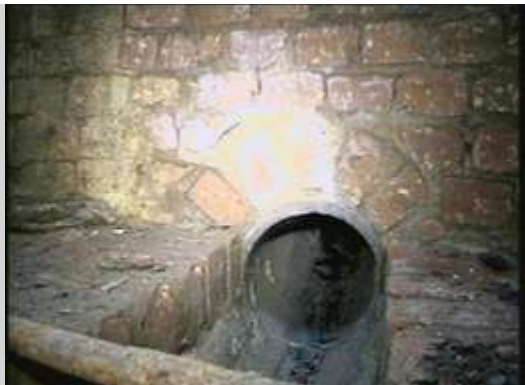
6 O'Clock Inflow

Deposits: ☐ None ☐ **Mud** ☒ **Sludge** ☐ Debris ☐ Grease

Silt Depth: 1 (in.) Deposits Extent: **Light**

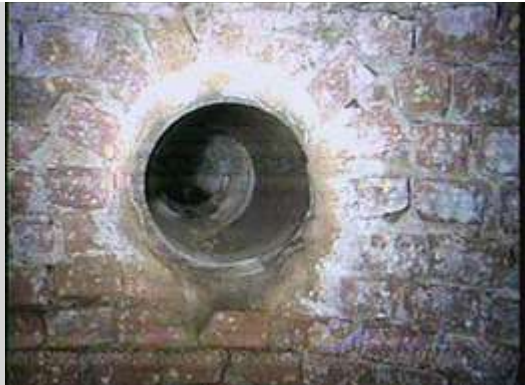
7 O'Clock Inflow

Deposits: ☐ None ☒ **Mud** ☐ Sludge ☐ Debris ☐ Grease

Silt Depth: **1** (in.) Deposits Extent: **Light**
